## Thermal Runaway

### Testing thermal resistivity - a measure of the soil's ability to carry heat away from cables

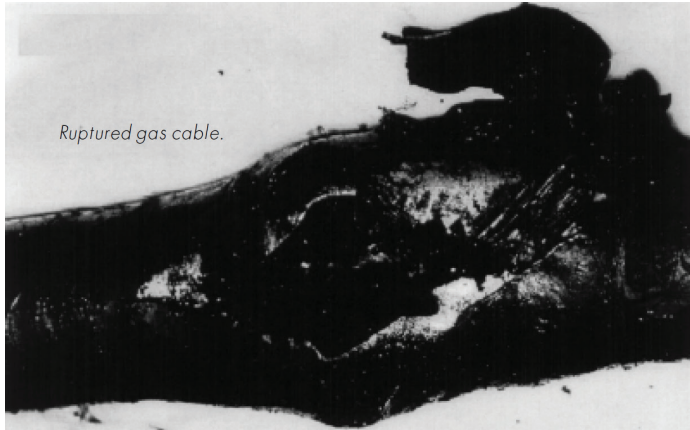
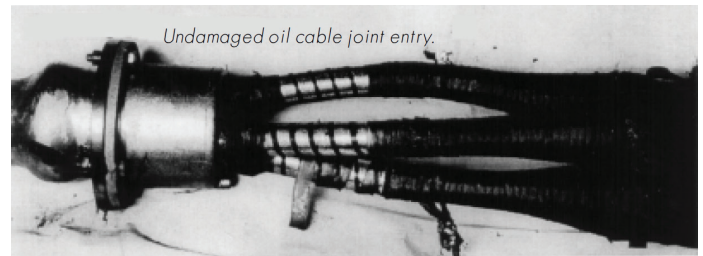
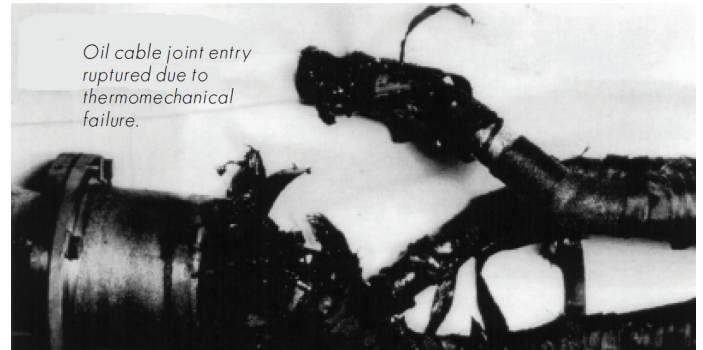
conditions are exceeded, either by passing too much current through the cable, or allowing the soil to dry around the cable, thus decreasing its thermal conductivity. Once the cable starts to heat, a positive feedback condition starts (similar to a microphone and amplifier in a public address system feeding back on itself). When a temperature gradient exists in soil, water tends to move from regions of high temperature to regions of low temperature. As the cable heats, the moisture around the cable is driven away, leaving the cable in dry soil. The thermal conductivity of dry soil is only about 1/5 that of wet soil, so the cable temperature has to rise substantially in order to dissipate the heat it is producing. This increased temperature dries an even thicker layer of soil around the cable, which results in even more temperature rise at the cable. The positive feedback produces a runaway condition where the cable temperatures become high enough to cause catastrophic cable failure, as is shown in the pictures.

Thermal runaway can occur in underground power cables. Because the cables carry current, they generate heat. The heat is dissipated to the soil surrounding the cable. The soil/cable system is designed so that, for the current normally carried by the cable and the thermal properties of the soil in which it is placed, the temperature of the cable will remain within safe limits. Thermal runaway results when the design
